# Silt Curtains

## Failure Modes

# Technical Note

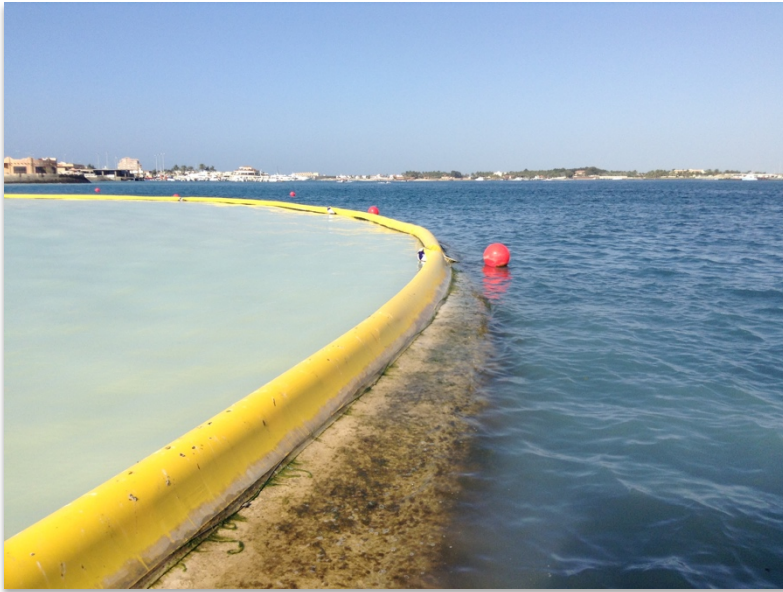
Submerged flotation at anchor points only	No anchor buoy on line, which causes curtain to be pulled underwater at the anchor point.	An anchor buoy should always be on the anchor line 0.5-1.0m from the anchor point on the curtain, to act as a shock absorber and provide a horizontal pull on the curtain.

Submerged flotation	Skirt has become buried by sediment or reclamation.	Very difficult to rectify. If a small area, divers can assist removing the material on the skirt. Using a crane will likely rip the skirt off in case of too much sediment. If unable to be removed, skirt may need to be cut at seabed level.

Skirt lifting up and floating on surface	Strong currents and insufficient ballast or too deep a skirt.	Longer skirts are subject to higher forces and can result in a shallower effective depth than a shorter curtain, which is difficult to fix after installation. Divers can add additional weight or curtain can be removed and reinstalled with additional ballast chain.

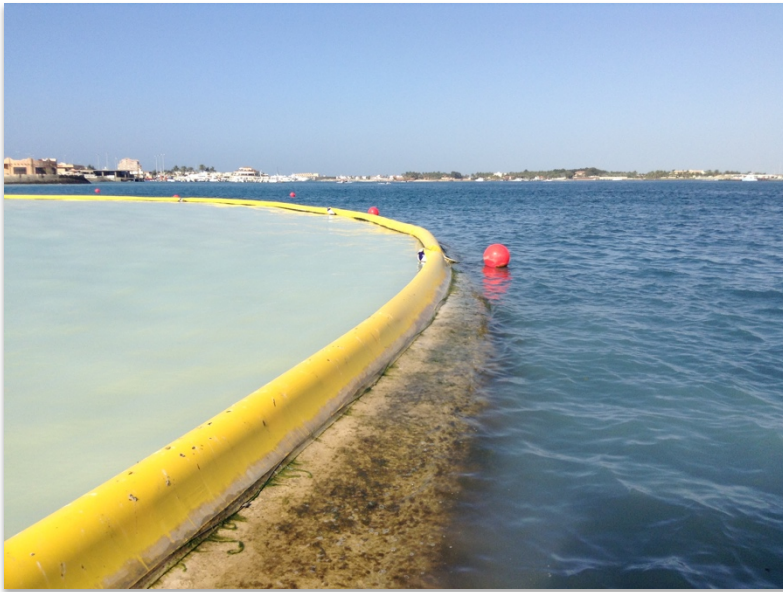
<b>Failure or Issue</b>	<b>Cause</b>	<b>Solution</b>
	Foam leaking through gaps in float pocket connections	Type I and II curtains are designed to close off at the top. Type III and IV are designed to have independently moving float pockets unless optional foam flaps are provided.	Type I and II – Check whether top float pockets are connected as per instruction manual. Type III and IV – Install foam flaps if provided, however, in most offshore conditions not recommended.
	Rips or tears in skirt visible	Incorrectly specified curtain type or improper handling.	Care must be taken when installing or relocating curtains to prevent damage, as these are the highest forces placed on a curtain. All curtains should be furled prior to relocating to reduce strain. If a new install, curtain may be under capacity for environmental conditions.
	Broken anchor lines	Incorrectly specified anchor system or vandalism.	Type I and II are designed for up to 18mm PP rope. Rope will break in conditions that require a Type III or IV. These curtains are specified with 24mm Nylon Rope. In the event of vandalism or boat impact, navigation buoys and lights should be used to demarcate the curtain.

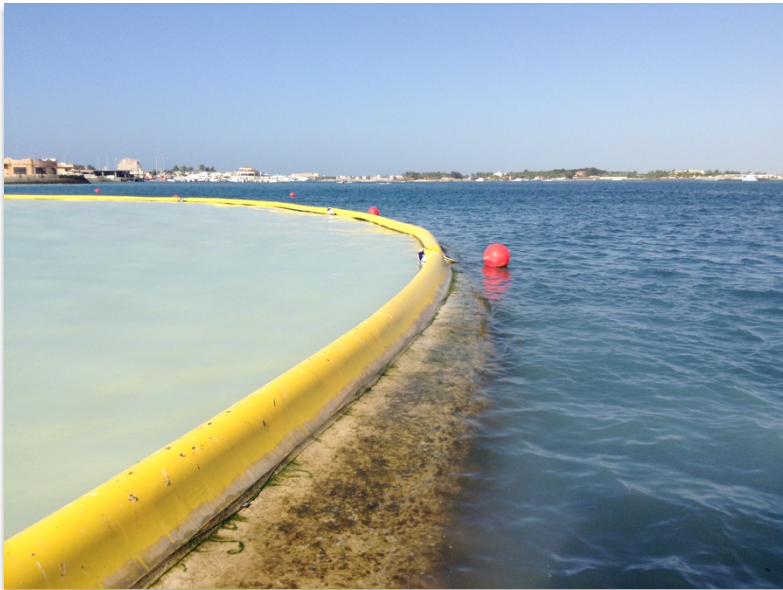
Failure or Issue	Cause	Solution
Rips in float pocket	Vandalism, boat impact, improper assembly or handling.	Float pockets should not be under force or tension. If rips are forming, which are not the result of vessel impact or vandalism, there is too much tension in the float pockets and they should be separated at the anchor points. In Type I and II, this usually means that the conditions are not suitable for this type of curtain. In Type III and IV, this usually means that the conditions are not suitable for foam flaps, and if present, these should be removed.
